**Subject: Site Inspection and Screening Risk Assessment for Dioxins/Furans
 Arkwood, Inc. Site, Omaha, Arkansas
 EPA ID# ARD084930148; Site ID: 0600124**

ChemRisk 11/19/2012 Site Visit
Photographic Narrative at Arkwood,
Inc. Site in Omaha, AR

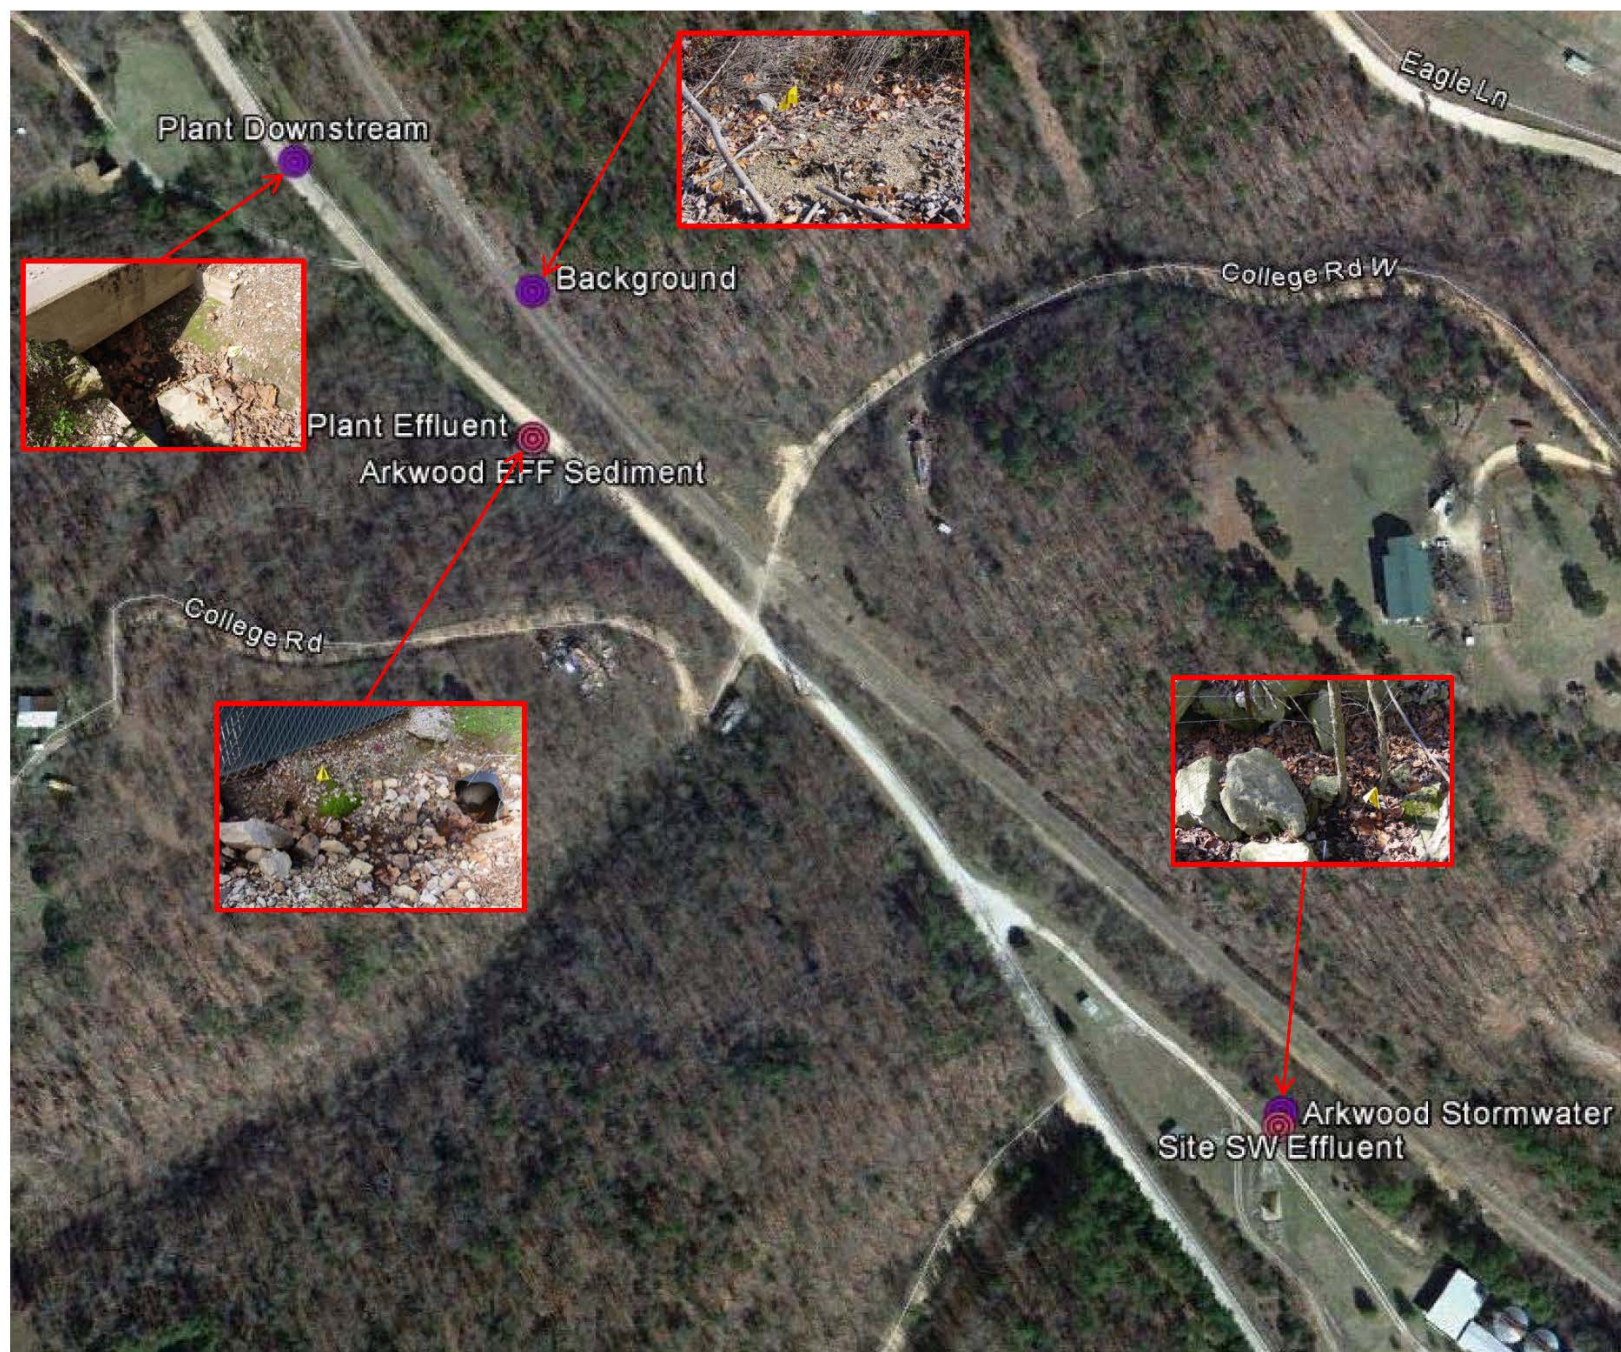
Figure 1: Sample Locations – Dioxin Sampling Events (9/24/2012 and 10/26/2012)

Four general areas were selected for PCDD/F sampling: 1) the on-Site stormwater ditch (Sample 1) and the natural berm adjacent to the stormwater ditch (Sample 2); 2) two sediment samples collected near the ozone treatment plant within 10-15 feet of the discharge point (Samples 3 and 4); 3) one off-Site roadside ditch soil sample downstream from the ozone treatment plant outfall, about half the distance to the downstream stormwater retention pond (Sample 5); and 4) a background location in a ditch adjacent to the railroad tracks about 0.5 miles away from the Site (Sample 6). An aerial photo depicting the sampling locations is attached (Figure 1). It should be noted that these samples were collected from zones with embedded rocks, vegetation, and leaf debris, and that rocks and debris were temporarily relocated to obtain sediment samples at 0 to 3 inches depth. All of the sampled ditches or confluence points were partially rock-lined either naturally or artificially in order to maintain ditch integrity. This rocky lining also limits access to these ditch sediments by people, and hence the use of these ditch soil samples for PCDD/F exposure concentrations in a risk assessment may overstate plausible exposures and risks. Further, the surface soils surrounding these ditches, both on-Site and off-Site, were confirmed to be well vegetated, and the ditches represented a small fraction of the total land surface on-Site and for the private lands adjacent to Cricket Road. Thus, the contact frequency with soils in these ditch areas is likely to be limited for risk assessment purposes. Also, given these conditions and the available Site history, there are no other complete pathways for on-Site contaminated sediment transport along Cricket Road other than the ditches between the ozone treatment plant and the stormwater retention pond at the Old Cricket Spring outfall.

The PCDD/F measurements are summarized in Table 1, and the laboratory data are attached in Appendix B. Two samples were collected at the main Site, one at the base of the stormwater ditch (328 ppt TEQ, Sample 1) and a second sample on the adjacent natural berm (1,598 ppt TEQ, Sample 2). The sample collected at the base of the stormwater ditch likely represents long-term accumulation of contaminated sediments onsite and may be influenced by pre- and post-remediation activities. The source of the contamination in the berm sample is uncertain, but is suspected to relate to the former ash pile originally located within 20-30 feet upstream before its excavation. Also, there were several large rocks on this berm and the adjacent down-sloping hillside, possibly indicating that no excavation was done in this

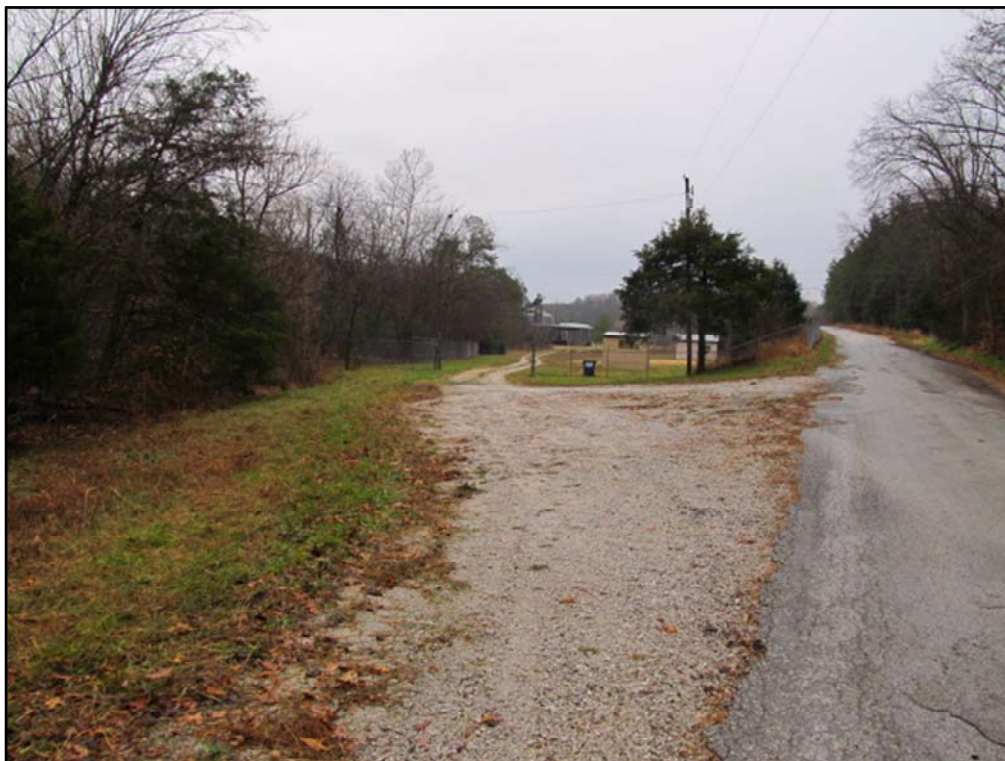
Offsite photo from Cricket Road looking SE towards entry gate of Arkwood, Inc. site. Paved road to the right rises with steep slope along hillside (borrow pit side) that overlooks the site.

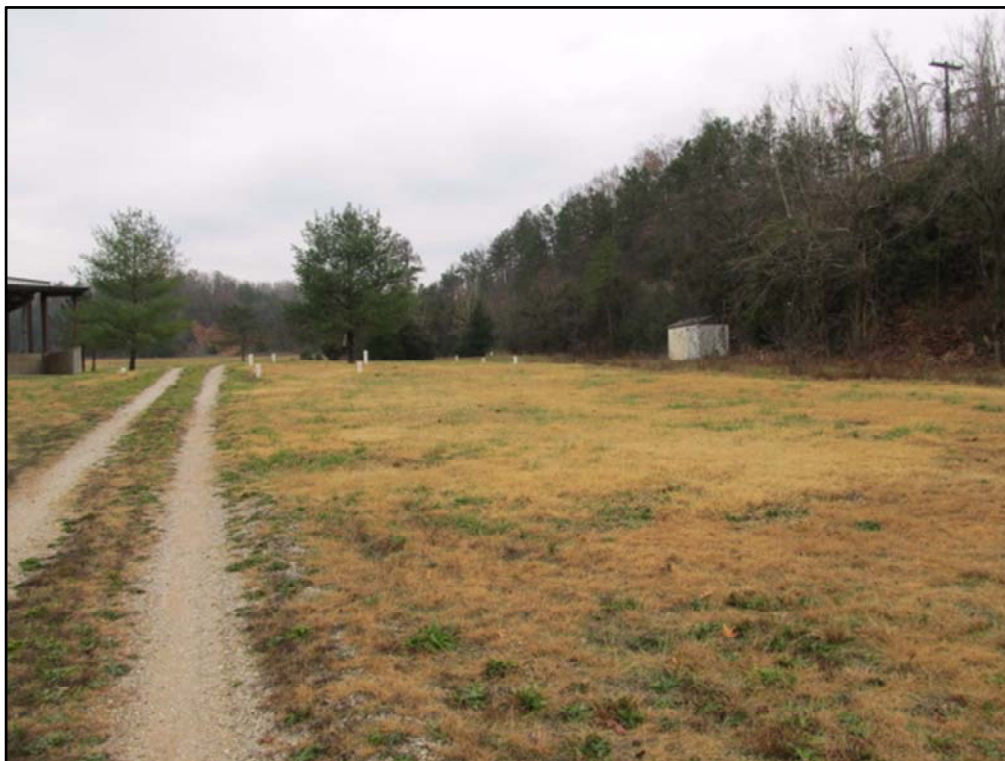
Onsite photo looking SE toward the white PVC injection points in the vicinity of the former sink hole area to the right of access road and concrete platform.

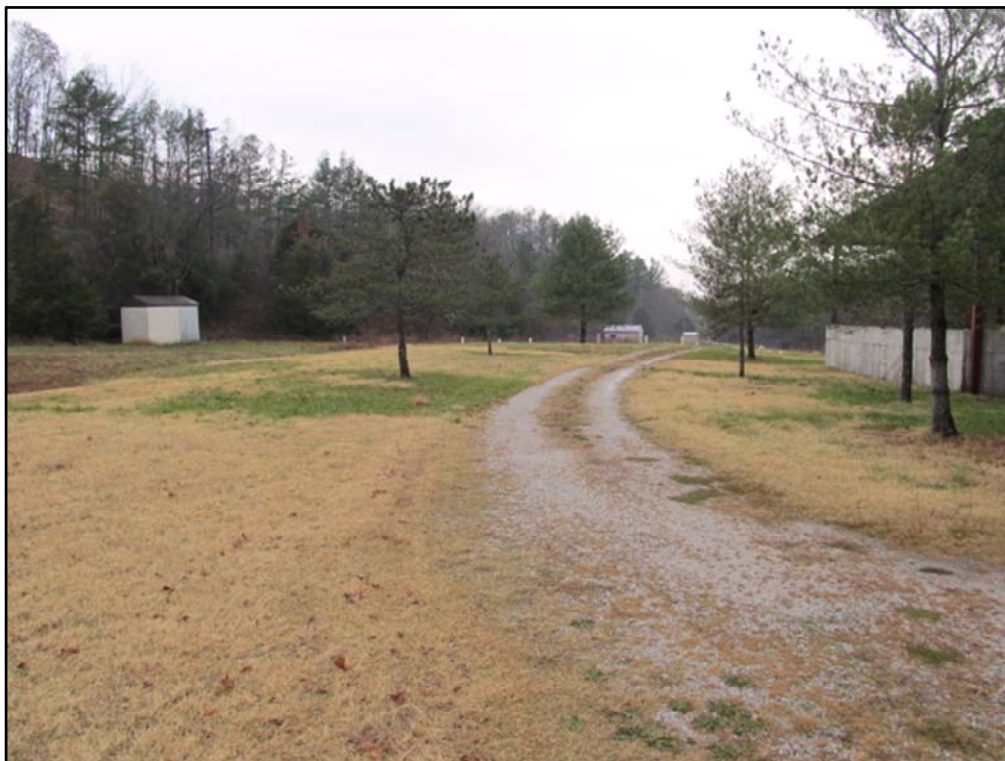
Photograph from onsite in front of concrete platform with bins, looking back NW towards entry gate and office; shows well vegetated cap with drainage ditch swales and steep sloping hillside to the left side.

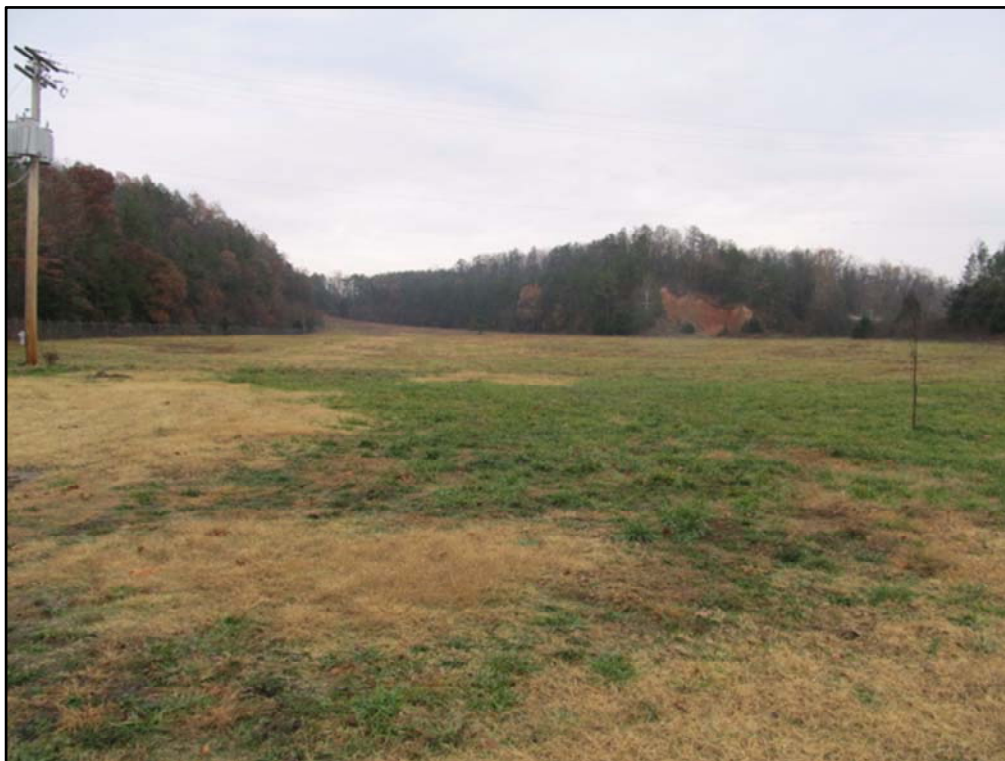
Photograph from onsite in front of concrete platform with bins, looking SE toward borrow pit area. Shows gradually sloping, well vegetated cap over entire site; shows that original site was a large plateau carved out from surrounding hillsides. Forms a basin with storm water drainage being well contained onsite.

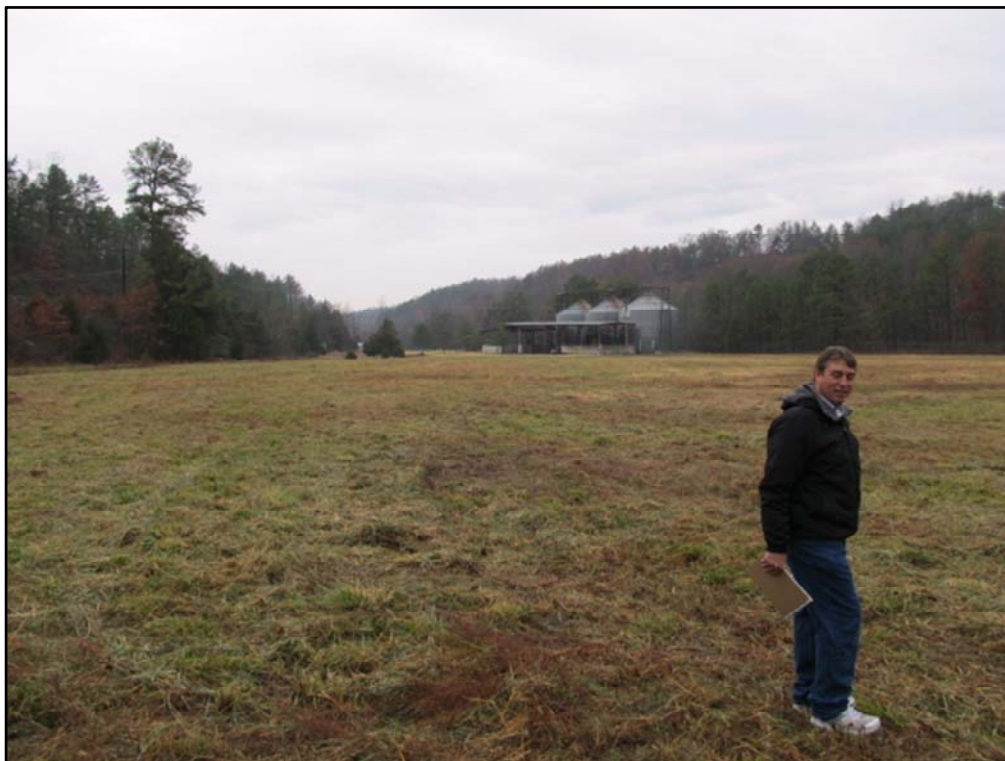
Onsite photograph looking back NW towards bins from borrow pit hillside area; shows well vegetated cap with gradual sloping plateau.

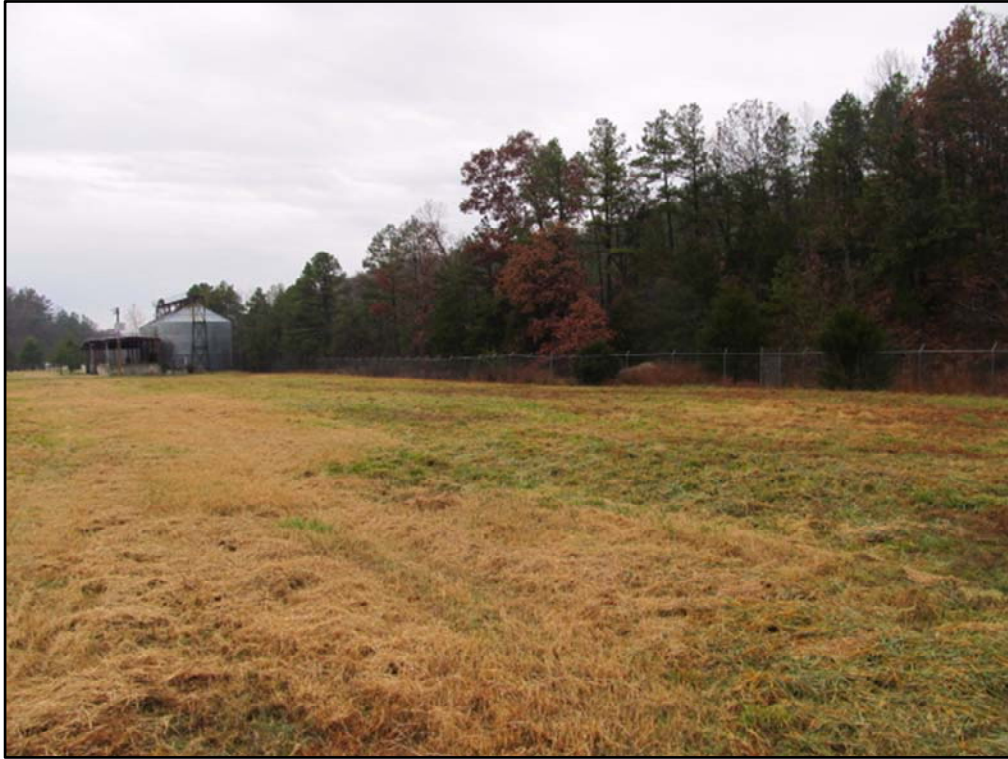
Onsite photo looking NW towards bins and fenceline with steep sloping hillside; railroad tunnel is located beneath this hillside about 15-25 feet below current grade.

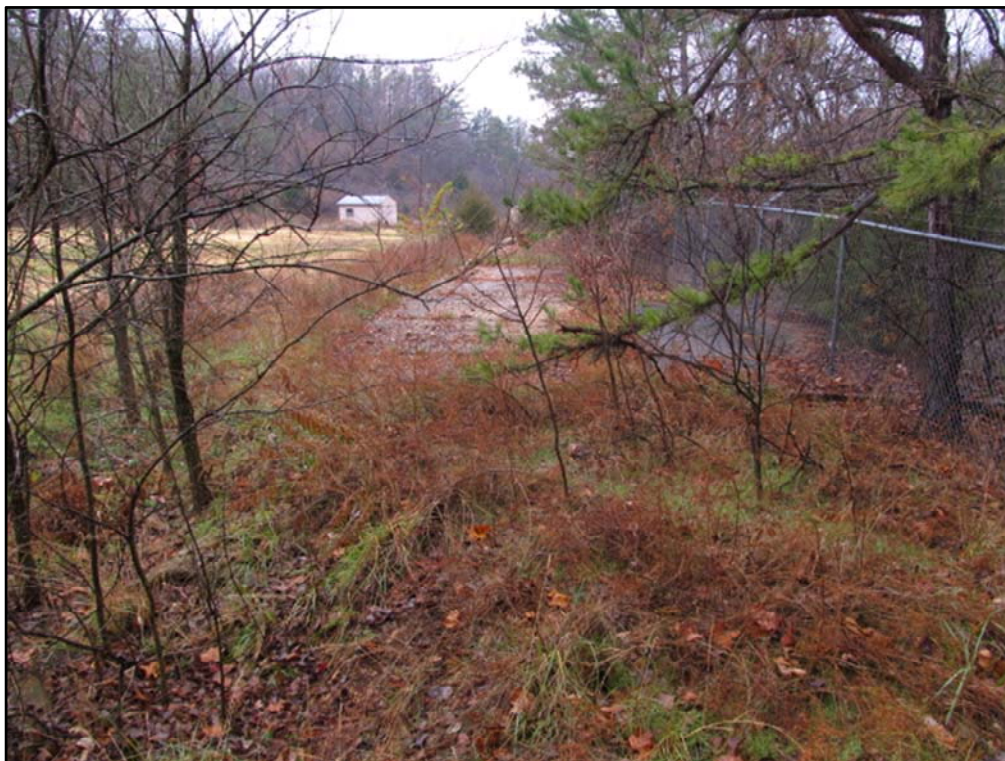
Onsite photo from concrete platform looking NW towards office and front gate. Former loading dock concrete platform adjacent to fence in center of photo. Drainage ditch is to the left and follows concrete platform, passes through former ash pile excavation area, and ends at natural berm at confluence of the two ditches between access road and fenceline.

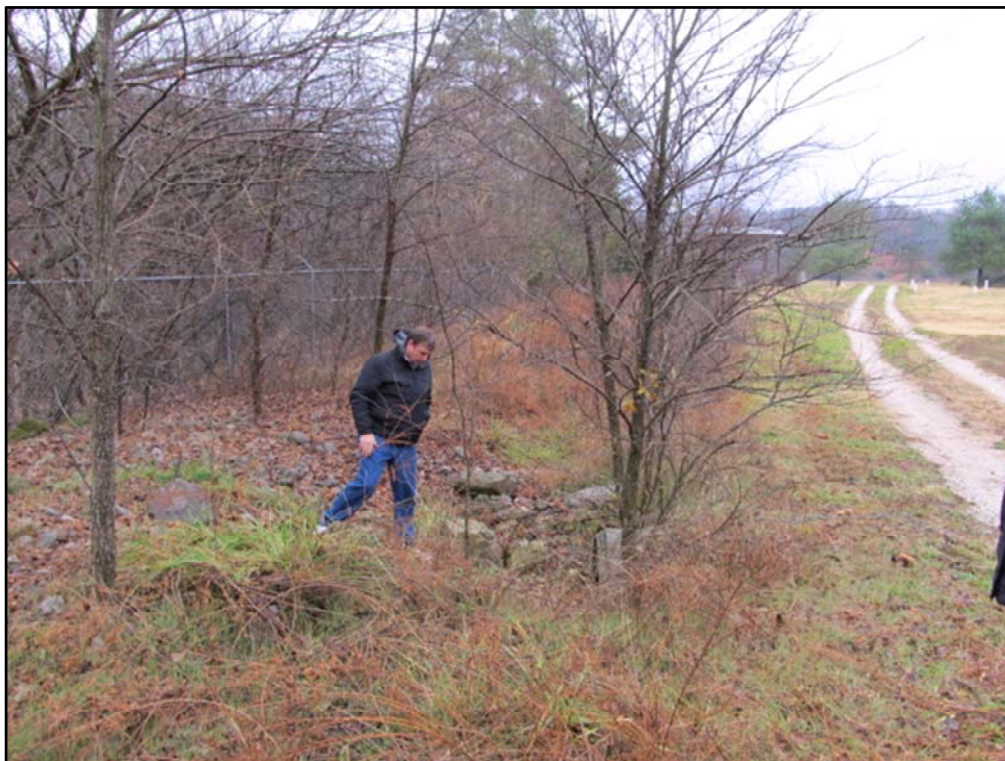
Onsite photo of rocky ditch area at the confluence of the two stormwater ditches, one which travels alongside the access road past former ash pile excavation site from the concrete platform and bins, and the other which travels along the opposite side (southern) of site and crosses under the road near the former vehicle decontamination pad.

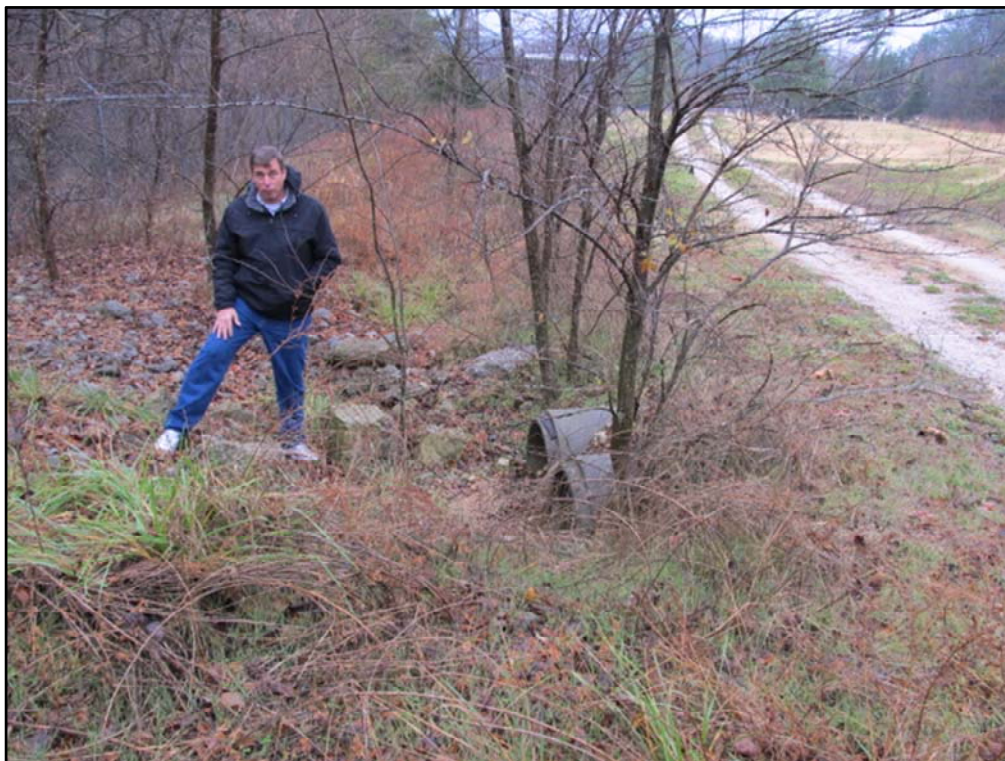
Onsite Photo showing yellow flag where Arkwood Stormwater sample was collected, near one of the stormwater pipes under access road. To the left of Mr. Fleer is the rocky natural berm ridge area where the 1,598 ppt TEQ sample was collected from between and beneath rocks.

specific location during the Site remediation. The sampler (Mr. Fler) had to scrape between these large rocks on the berm in order to obtain a sufficient sample volume for the soil analysis.

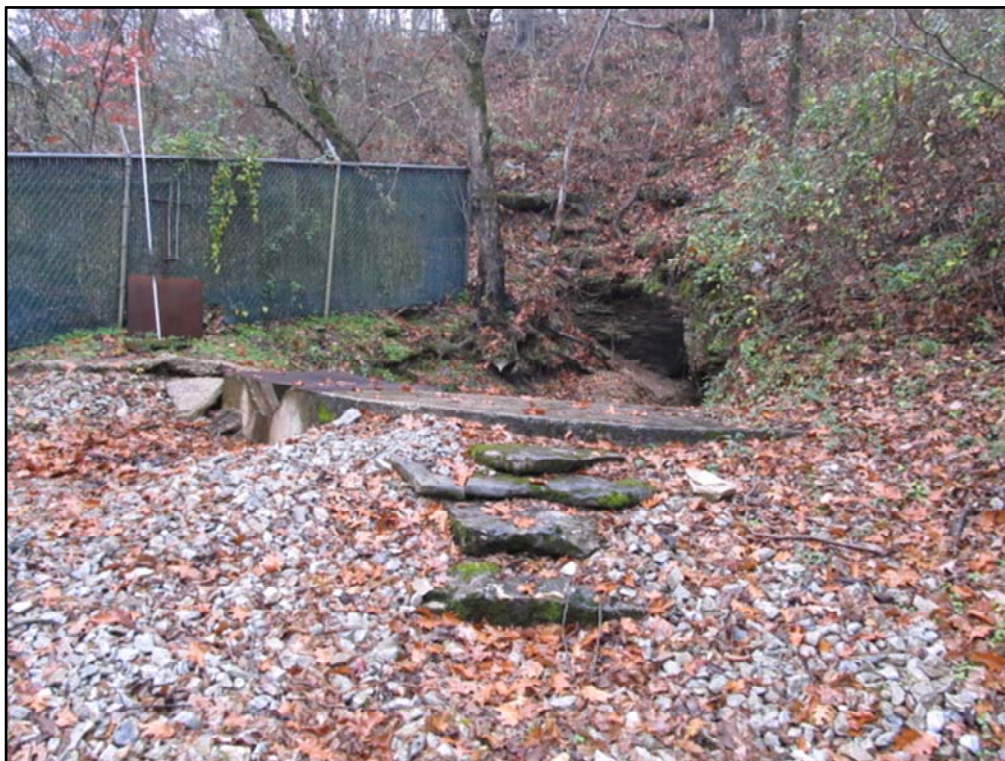
Ozone Treatment Plant area photo looking at the concrete berm and outfall of New Cricket Spring (located about ¼-mile NW of the Site. New Cricket Spring drains the Karst formation beneath the site. A mild diesel fuel odor was noticed at New Cricket Spring on the day of inspection. Water from spring area is pumped to the ozone treatment plant via underground piping.

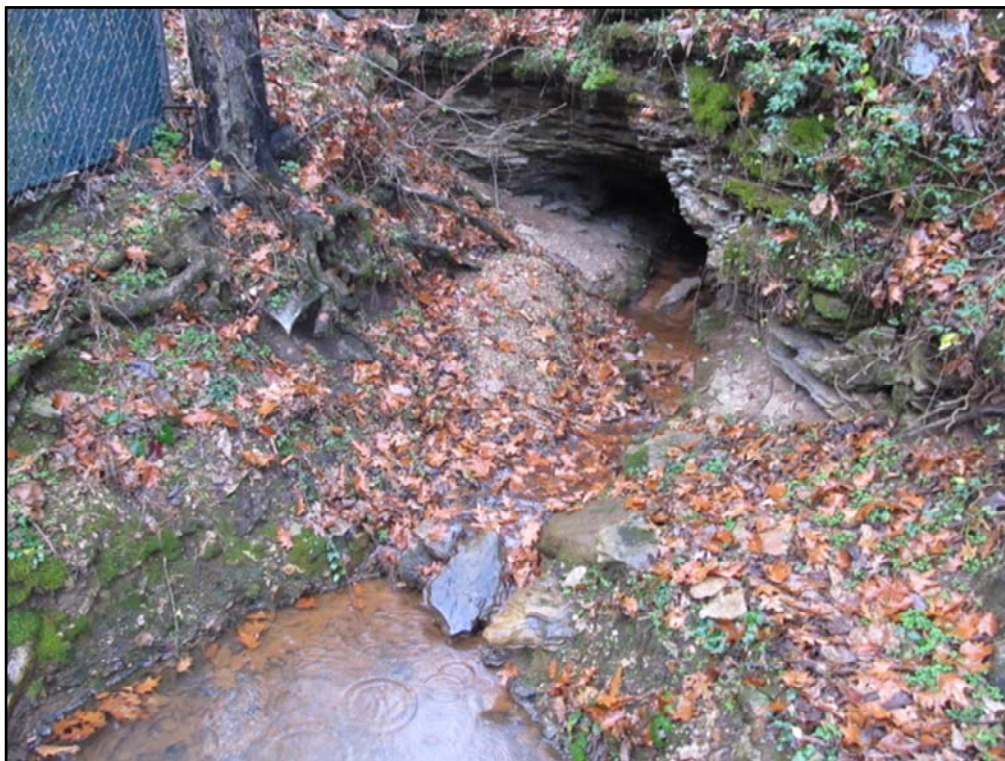
Photo looking down into New Cricket Spring. Mild diesel fuel odor was noted here, but no oil sheen was observed in water.

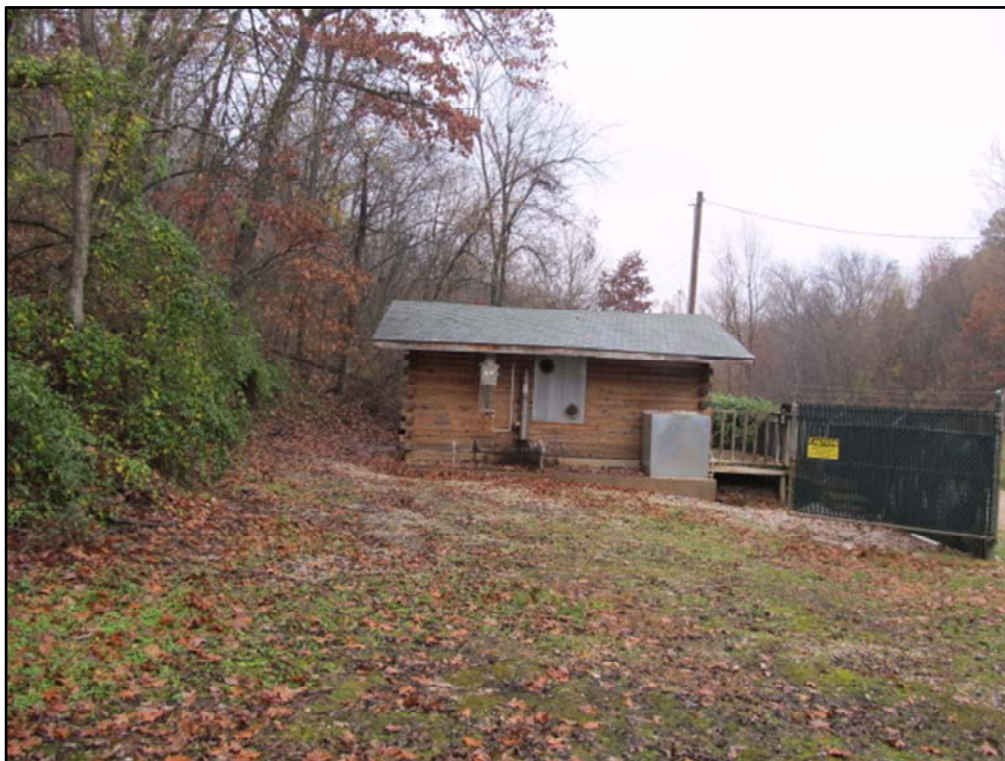
Ozone Treatment Plant photo looking at building that houses the ozone treatment system. Treated water exits the building at pipes visible near center of building, and travels below the grated platform to a roadside ditch to the right of building.

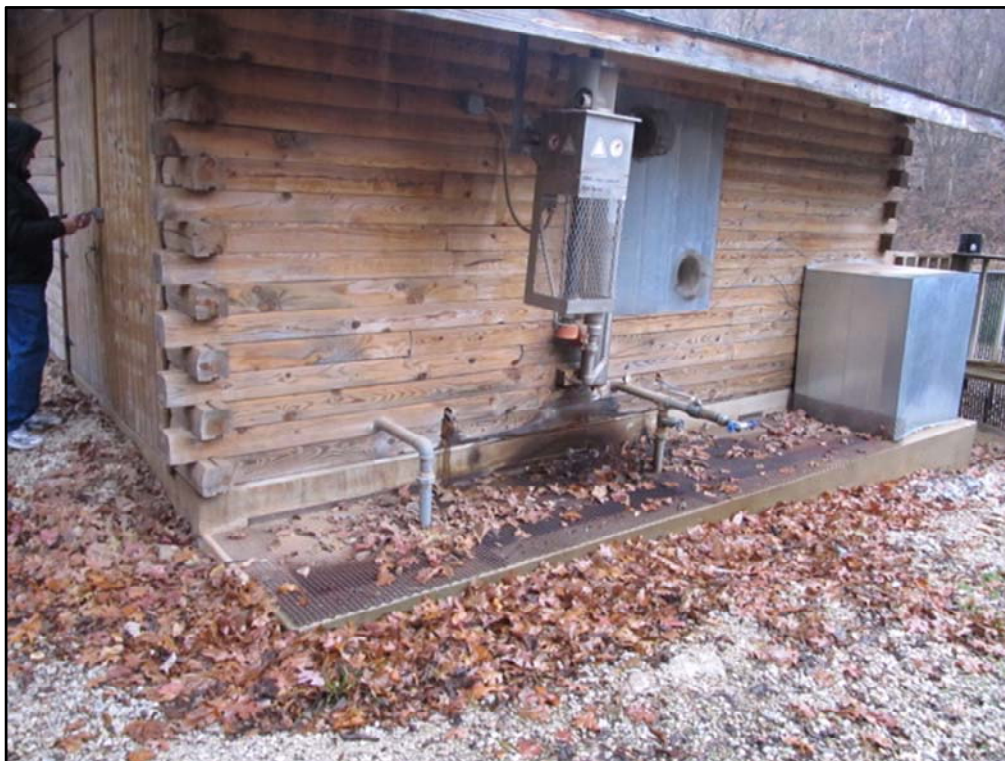
Ozone Treatment Plant building: close-up photo of the inlet pipe and outlet pipe for ozone-treated water that travels under grated platform to roadside ditch.

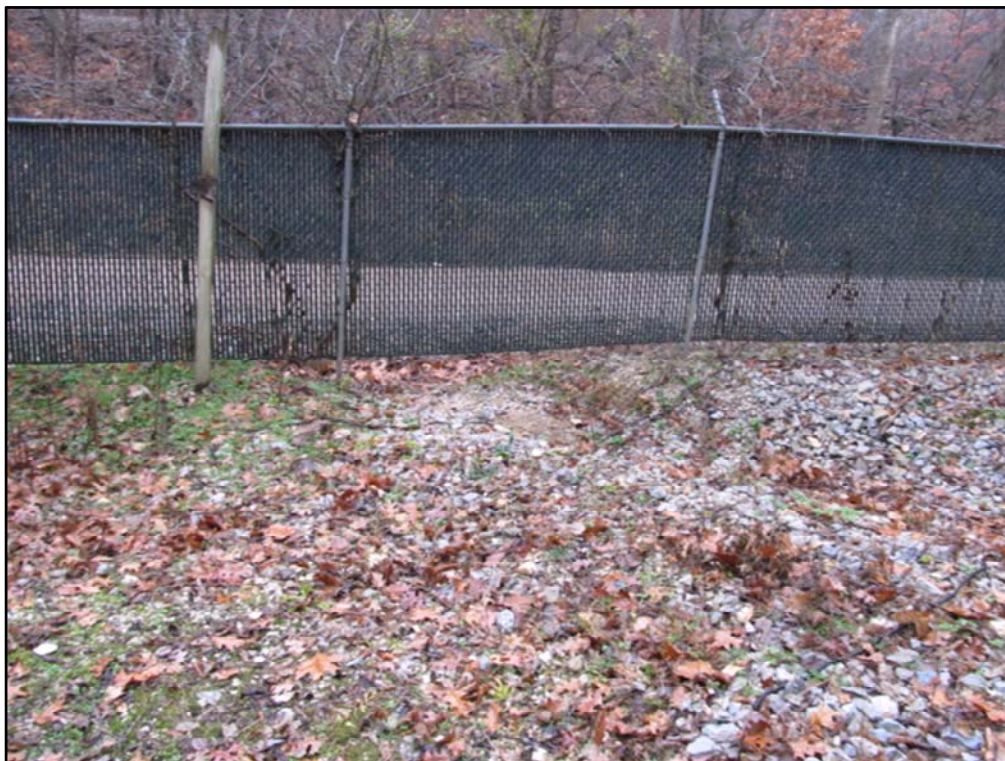
Ozone Treatment Plant area photo showing overflow swale between New Cricket Spring and roadside ditch at Cricket Road. Entire area is very rocky with interspersed vegetation. Cricket Road is visible on other side of fence.

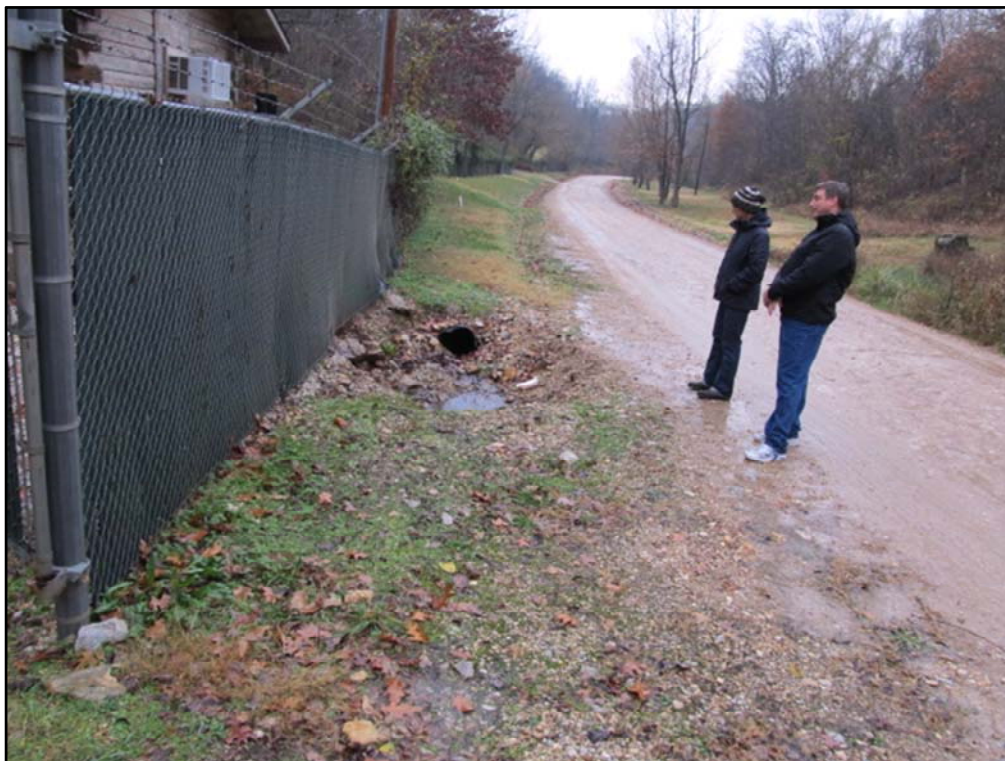
Ozone Treatment Plant area photo looking NW towards roadside ditch where ozone-treated water exits beside Cricket Road. Entire area is very rocky with interspersed vegetation. Two sediment samples were collected at this ditch by relocating rocks and digging beneath to obtain sediment. A plastic corrugated pipe was laid in the former roadside ditch downstream and covered with soil and vegetation from this location to the under-road crossing point down the road about 300 feet.

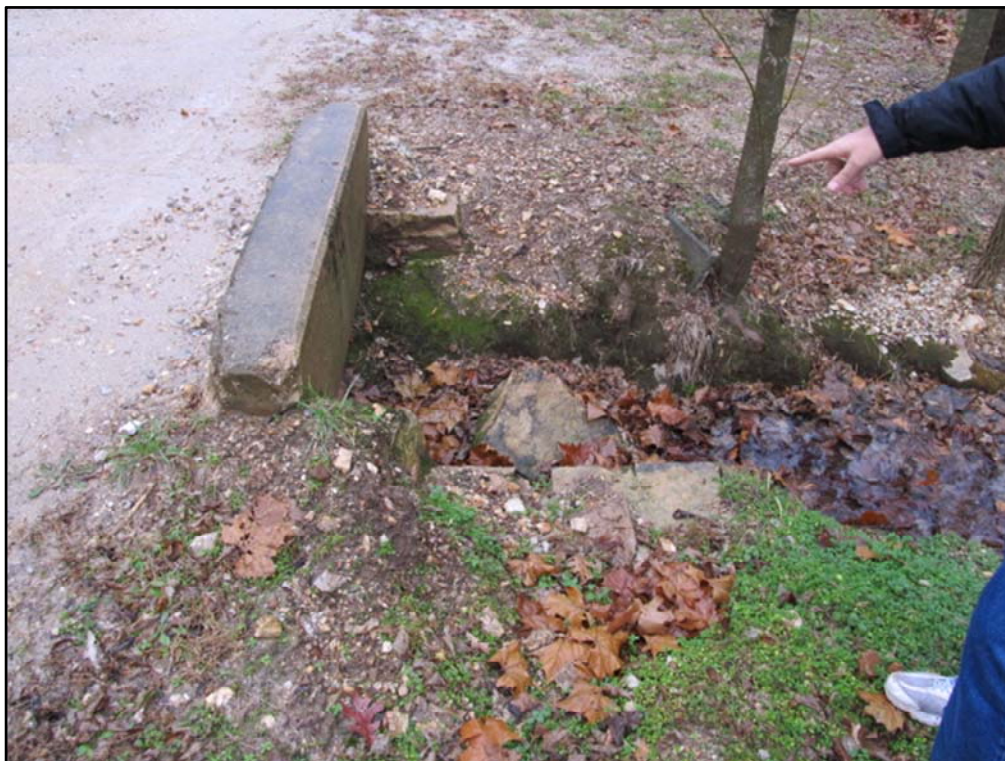
Close-up of ditch on opposite side of road from Ozone Treatment Plant where drainage pipe crosses under road. All of ditch area is rocky with some leaf litter and interspersed vegetation. This is the location where the downstream effluent sediment sample (Sample 5) was collected.

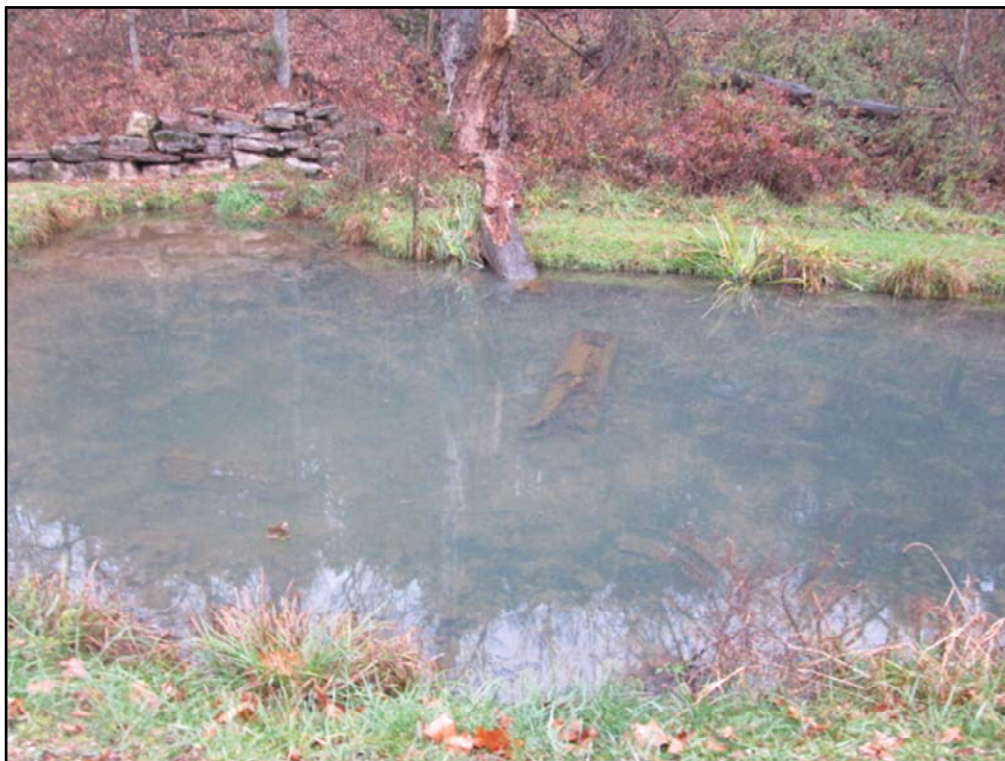
Close-up photo of retention pond showing rocky bottom and wood debris, and elevated grassy bank around pond. No diesel odor or oil sheen was observed here or at any point in the drainage path after New Cricket Spring.

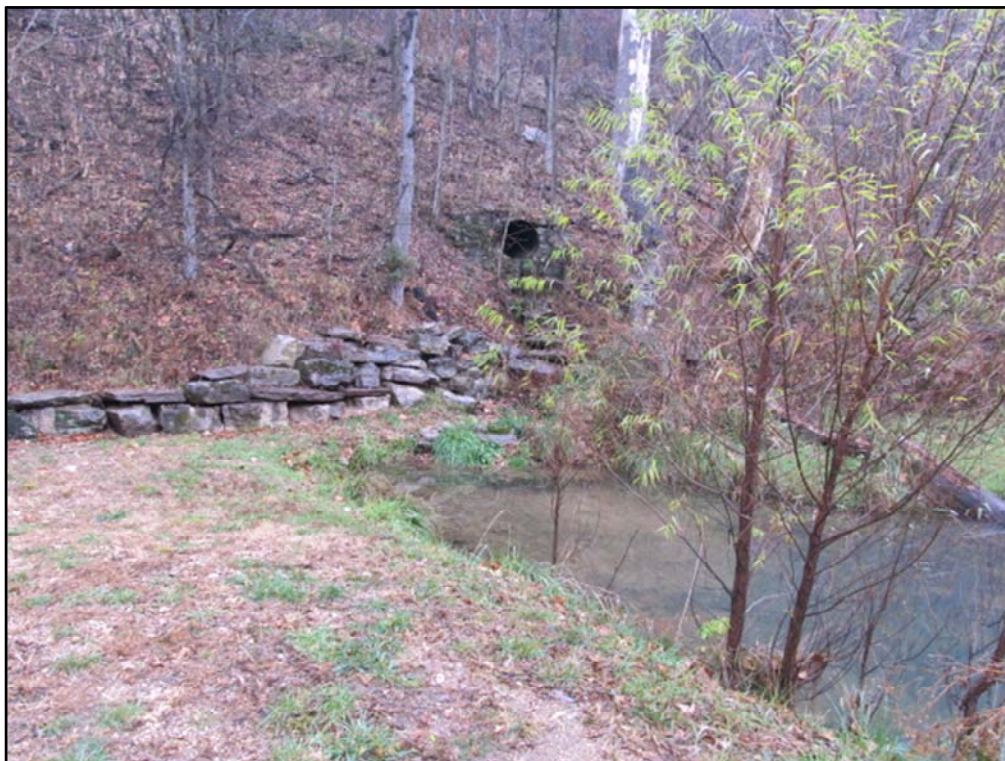
Photo from retention pond showing drainage pipe (Old Cricket Spring) in the hillside and rock structures to prevent erosion.

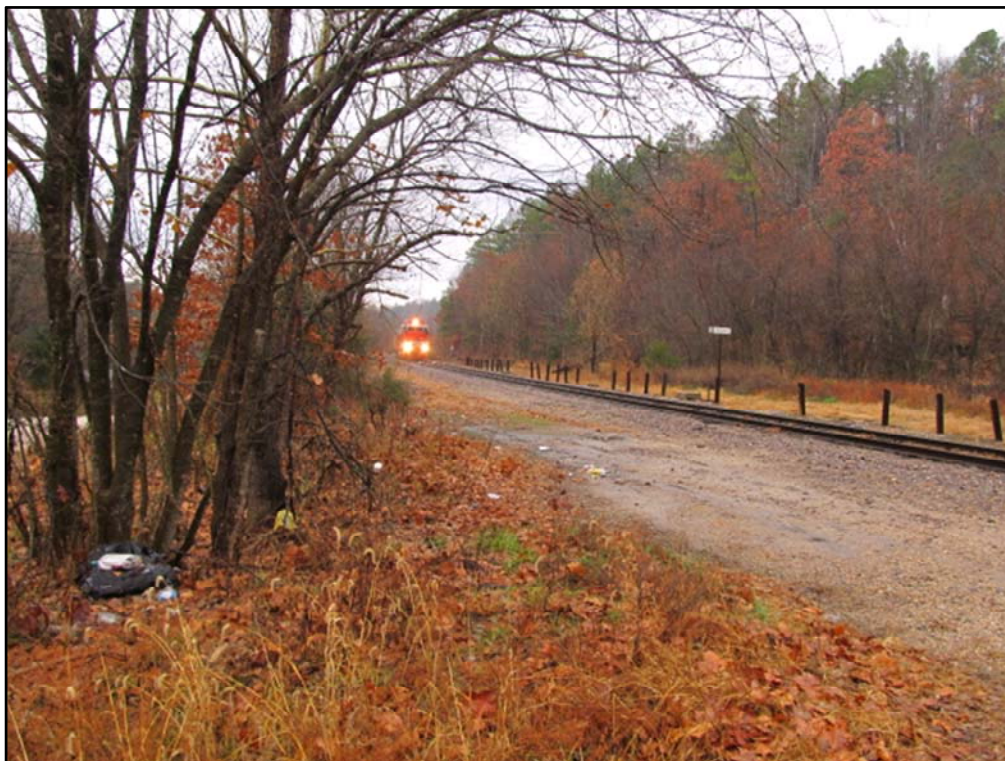
Photo of train tracks in active use from College Road crossing at Cricket Road. Background ditch sample is located on right side (NE side) of tracks approximately where the train is positioned in this picture.

A background soil sample collected from the ditch adjacent to the railroad tracks about 0.5 miles from the Site showed a substantially lower concentration (43 ppt TEQ, Sample 6 in Table 1). This sample may have been influenced by railroad operations, but was not in the historic downstream sediment transport pathway from the Site.

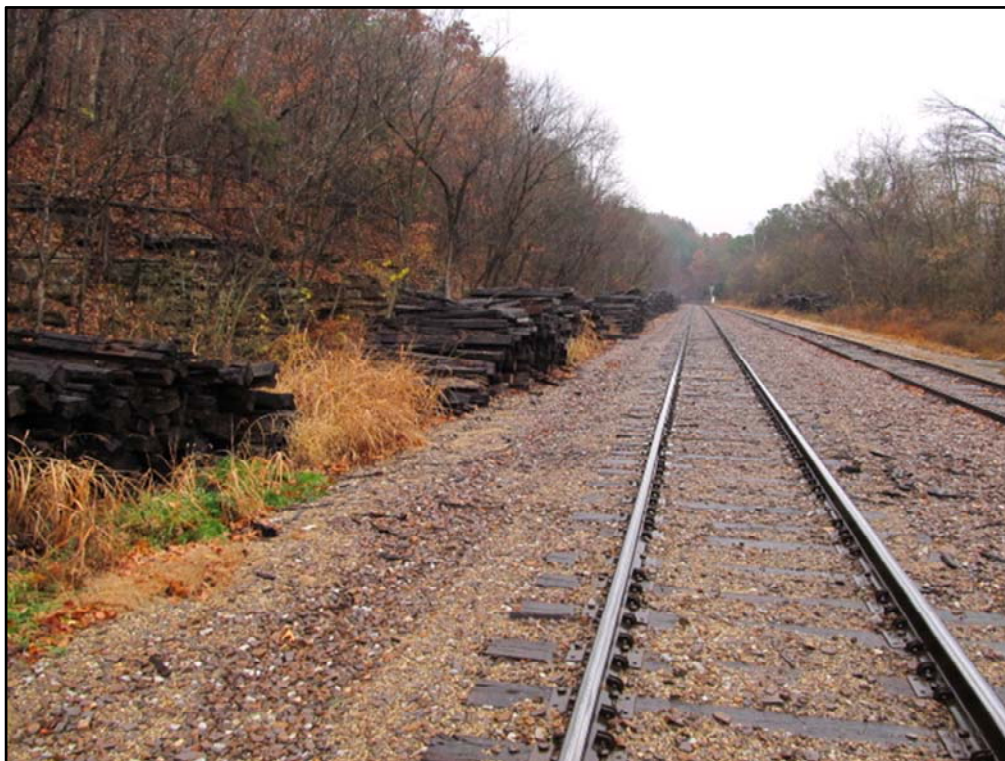
Photo looking SE of used railroad ties stacked up beside tracks between College Road crossing and railroad tunnel entrance adjacent to Arkwood, Inc. site. Piles of railroad ties are located on both sides of tracks as one approaches the Site.

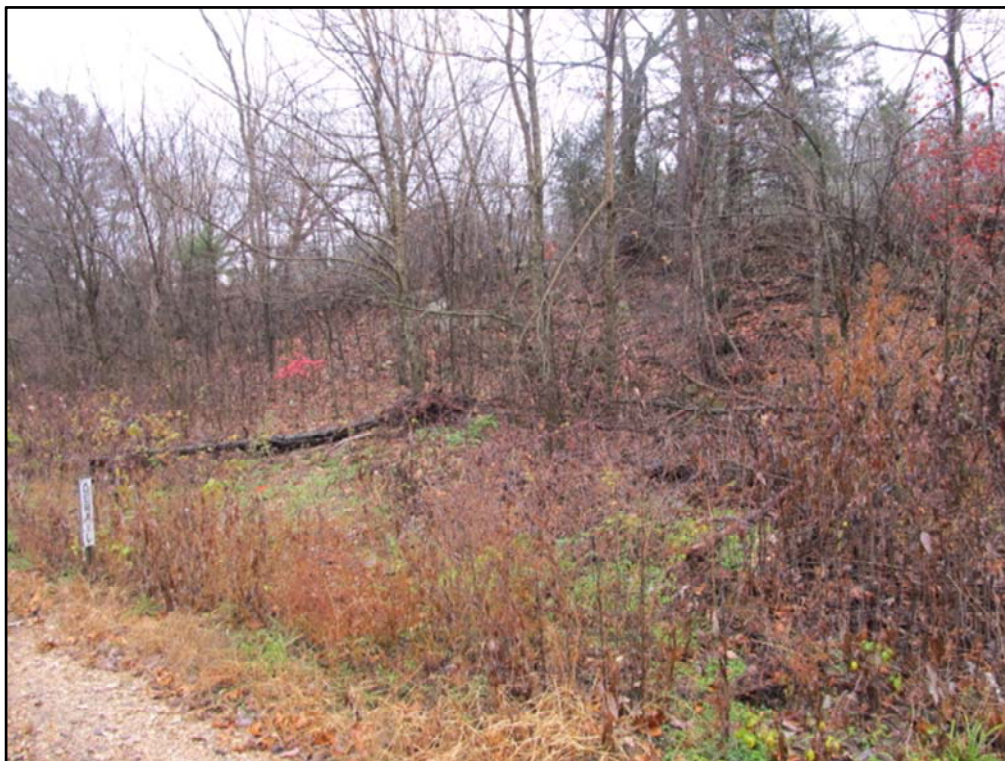
Photo looking SE of hillside where natural berm area may drain from the Site in high stormwater events. Hillside is rocky and vegetated.

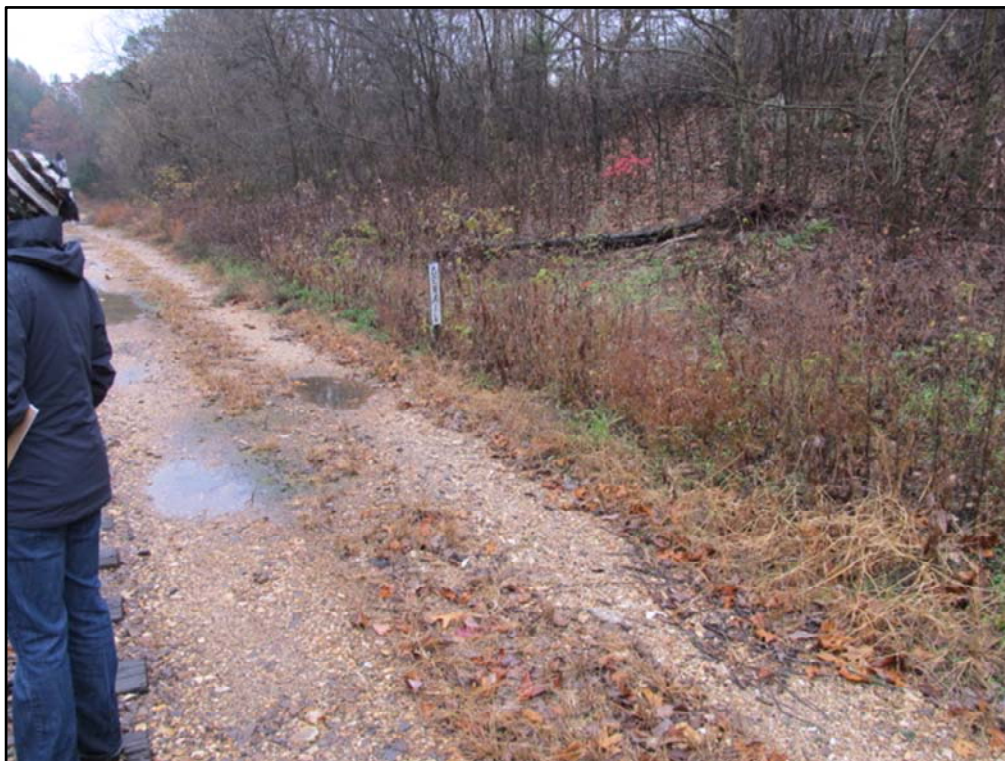
Photo looking SE of ditch between railroad tracks and hillside where natural berm may overflow during high rain events. The ditch and adjacent railroad foundation are relatively flat in this location.

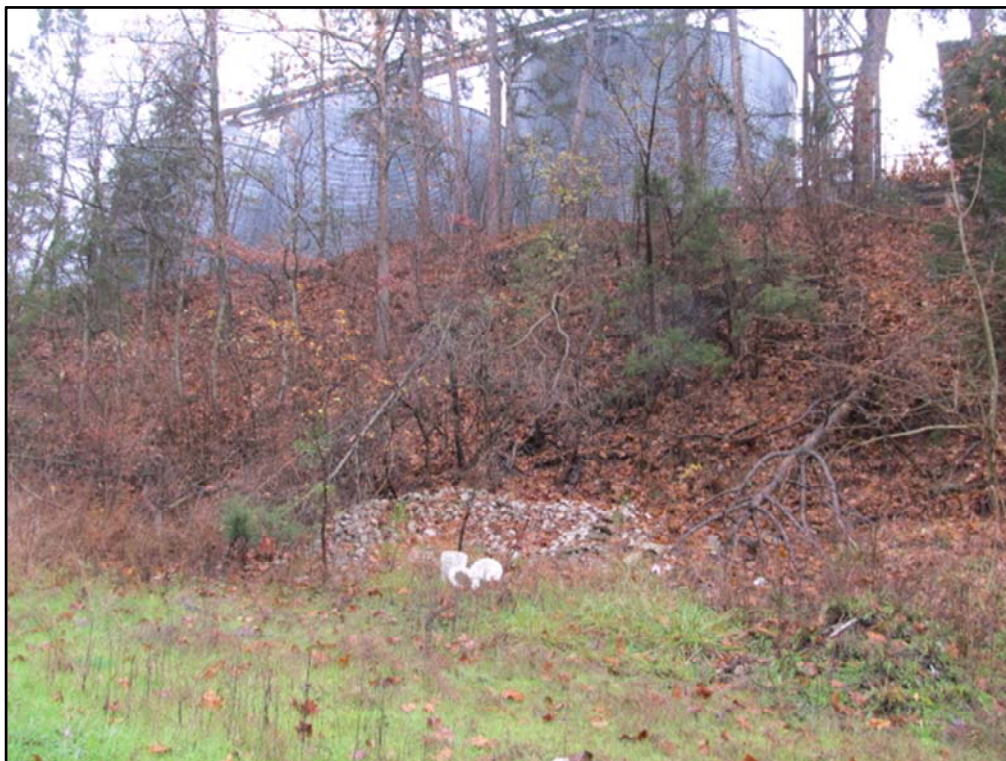
Photo from tracks looking S towards Site. Vegetated area in foreground is former excavated railroad ditch area. Some garbage dumping from local residents is apparent in center of photo.
